Sborník vědeckých prací Vysoké školy báňské - Technické univerzity Ostrava
číslo 1, rok 2007, ročník VII, řada stavební

**THE INTEGRATED DESIGN OF BUILDINGS ON INDUSTRY AREA, CASE STUDY FROM
STRUCTURAL STATIC AND ENERGETIC STANDPOINTS**

3.1 Case study No. 1 - administrative and office building in the former Odra Coal Mine in Ostrava-Přívov (original purpose)

3.2 Case study No. 2 – administrative and office building of former Severomoravské plynárny (North-Moravian Gasworks) in Ostrava

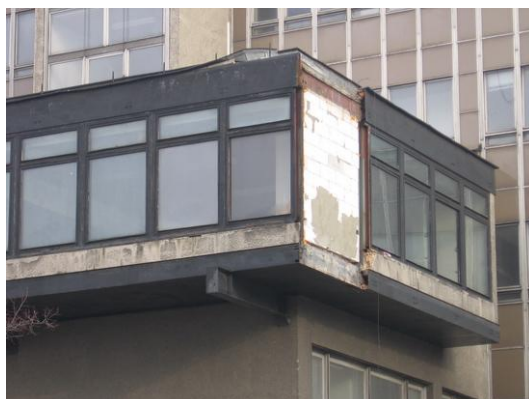
Fig. 2: Details of the facade on the administrative and office buildings ("Boletice" panels, steel skeleton, and metal windows)

In accordance with requirements set forth in [3], individual building structures in the building were evaluated from the point of view of thermal and technical assessment. The existing thermal parameters of the structure do not meet standard requirements [3]. Example: The heat transmission coefficient of ceramic panels in the building is $U = 1,64 \text{ W} \cdot \text{m}^{-2} \cdot \text{K}^{-1}$ and that of the light-weight external cladding from "Boletice" panels is $U = 1,07 \text{ W} \cdot \text{m}^{-2} \cdot \text{K}^{-1}$. These values are much higher than standard requirements ($U = 0,38 \text{ W} \cdot \text{m}^{-2} \cdot \text{K}^{-1}$).

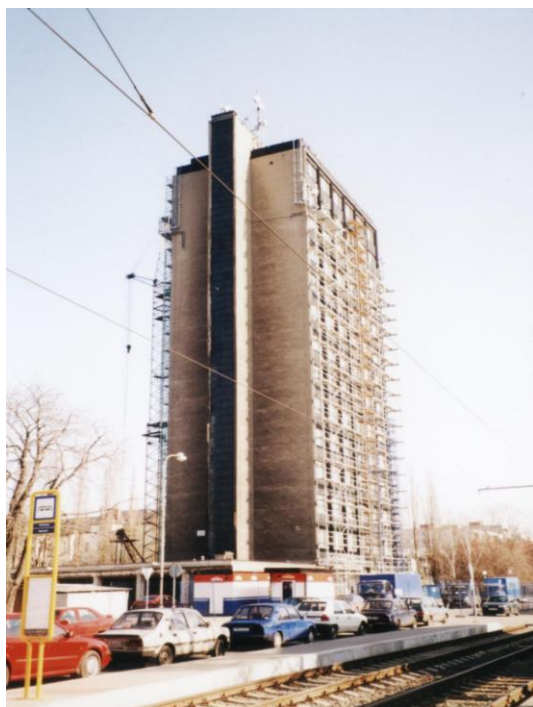
Fig. 3: Administrative and office building of former SMP - the original situation

The original building had 15 floors (plus the 16th floor as an additional storey with a boiler room in the roof). It was built in the 1970s. The external cladding was from light-weight metal and plastic with metal windows. From the static point of view, the building consisted of four longitudinal cast-in-place reinforced-concrete frames that created a three corridor structure. Ceilings were from prefabricated panels. Static load capacity of all structures was sufficient with a certain reserve for an extra load [6]. The reconstruction and modernisation did not change the function of the building [5] and effective loadings of the floors remained same [4]. What was special in the project was that two upper floors (the 14th and 15th floors) and the additional storey in the level of the 16th floor) were demolished in order to create a balanced appearance of the building in line with requirements. The demolished floors were replaced with a new steel structure of new floors. The structure is advanced, fresh and attractive from the architectural point of view.

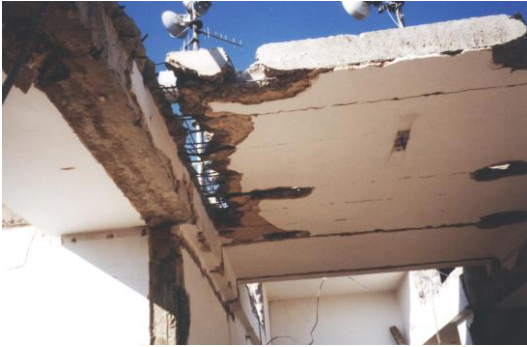
Fig. 5: PZD board ceilings in the additional storey on the roof were released from support faces

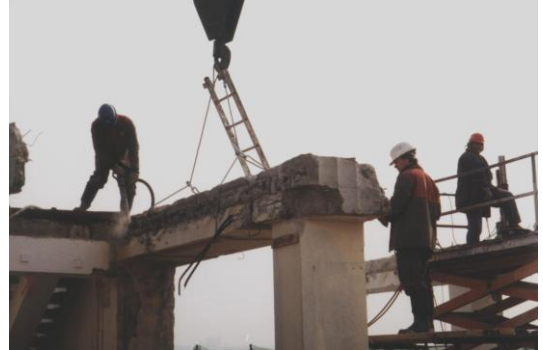
Fig. 6: All load carrying components (such as ceiling panels and girders) were drilled off in support faces. It was not possible to use another demolition method.

Consequently it was decided to drill out horizontal components (the floor girders and ceiling panels) close to fastening points (in the support face). It was of course necessary to suspend the element in such a way so that the static parameters could be maintained.

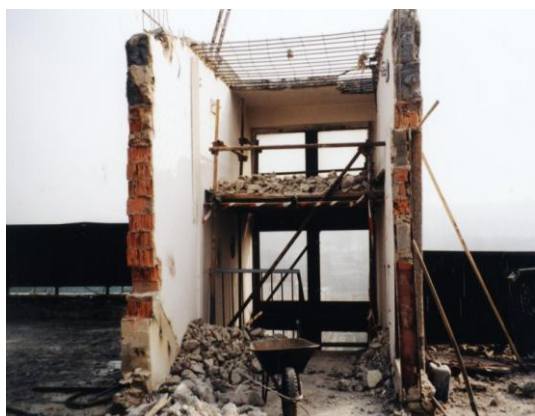
Fig. 7: After demolition of the 14th and 15th floors, the structure of the staircase remained.

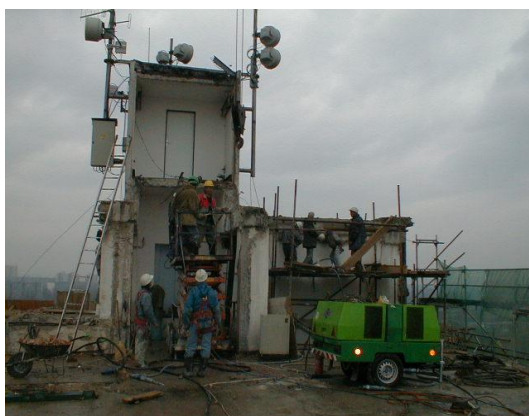
Fig. 8: A condition was (after demolition of the 14th and 15th floors) to keep the elevator shaft as well as aerials of mobile phone operators and automated control systems operated by Severomoravská plynárenská a.s.

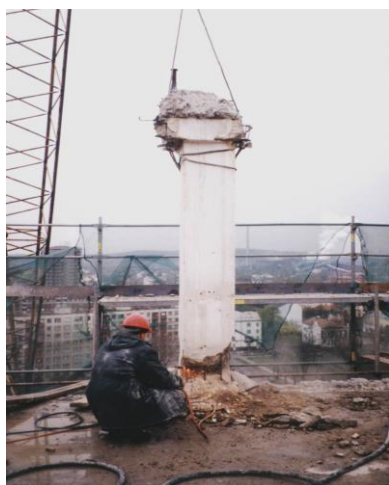
Fig. 9: Isolated columns were suspended and separated in the footing with a pneumatic hammer, the reinforcement was separated with a flame.

When removing the structure, a continuous or interrupted gap is created and the bigger element is removed from the remaining structure. In case of generally big volumes and weights, the element is divided into two or more rather small elements. A saw, demolition hammer, or drill hammer can be used to create a separating gap. Or it is possible to drill a row of holes (this was the case in the example above) very close to each other. In order to separate the structure easily, special hydraulic presses can be inserted into the gaps. This is used for reinforced structures mainly because it is rather easy to interrupt the reinforcement in the gap, unless drilled out earlier.

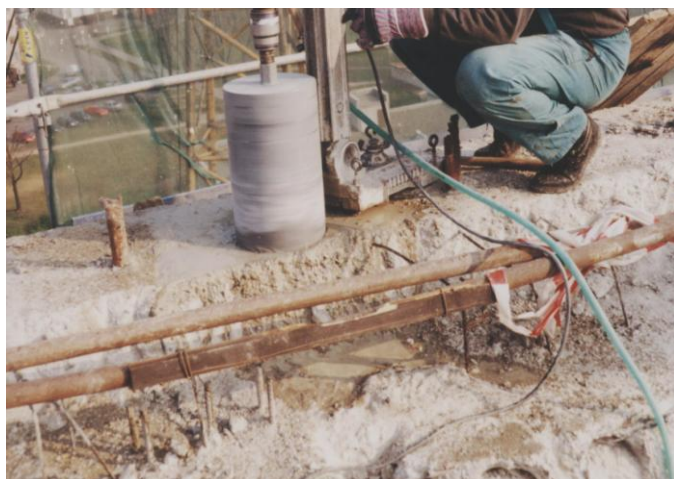
Fig. 10: The girder was drilled out to the core in the column face under the girder.
